## Two Career Fire Fighters Die in Four-Alarm Fire at Two-Story Brick Structure - Missouri

## Fatality Assessment and Control Evaluation Investigative Report #F2002-20

### *Two Career Fire Fighters Die in Four-Alarm Fire At Two-Story Brick Structure - Missouri*

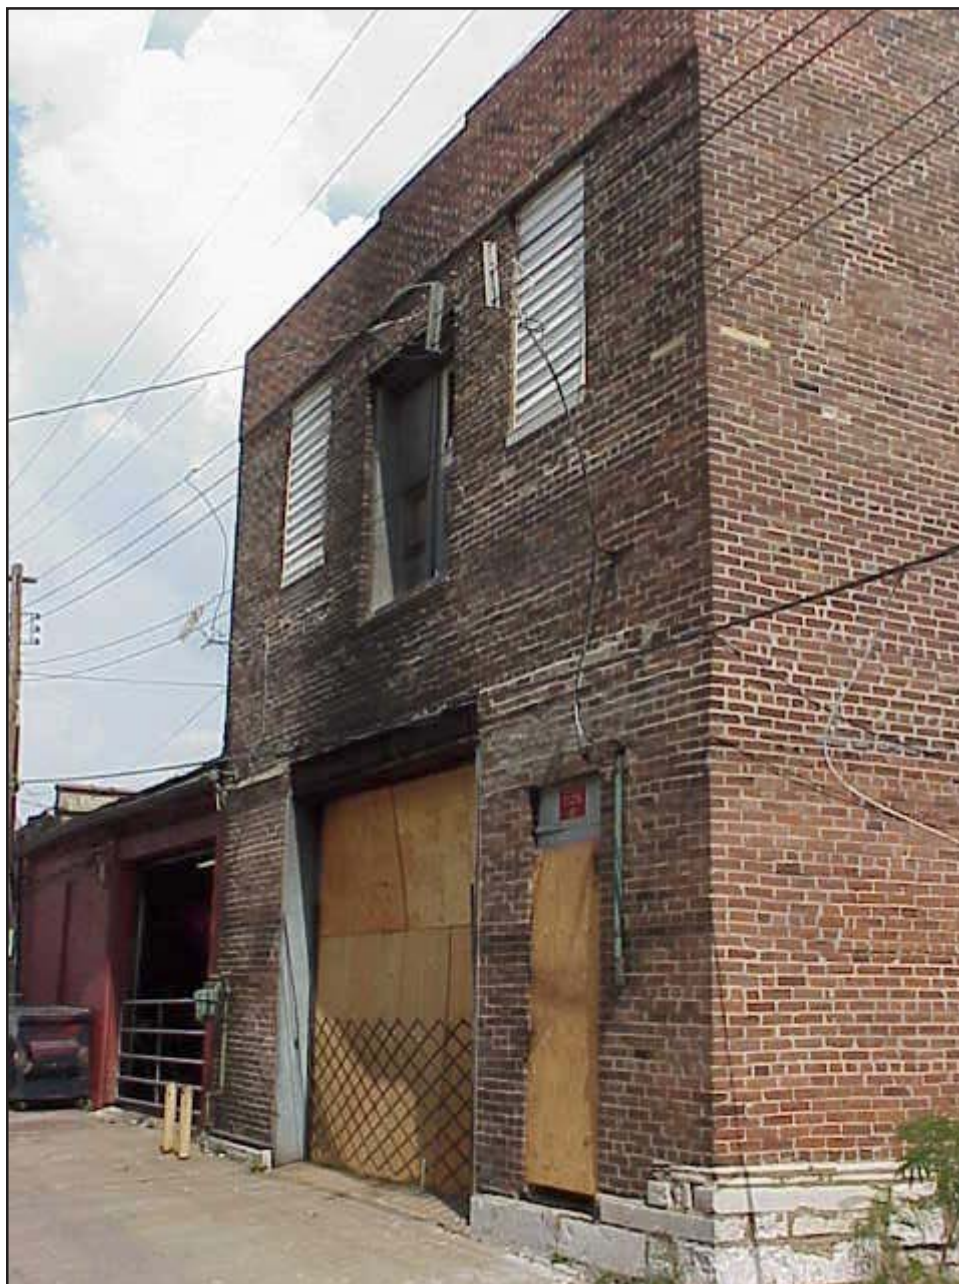
*Photo 2. C-Side*

The two-story commercial brick structure was of ordinary construction, situated in a connected row with several other properties with variable roof heights. The roof of the involved structure was relatively flat and sealed with built-up roofing materials. There were two entrances on the A-side at the ground level (Photo 1). The west entrance led to the upper level via a stairway, and the east entrance accessed the lower level through the doorway. Both entrances were secured by a padlocked swinging wrought-iron gate/door. There were no man doors noted at the lower level from the B- or D-sides (Diagram 1); however, there was one man door on the west end of C-side and a gated garage door at the east end of the C-side (Photo 2).
